15 7015 0415 0244

Hadfield Road
over
Beaver Creek

INSPECTED: October 28, 2010 - Routine

PREPARED BY:

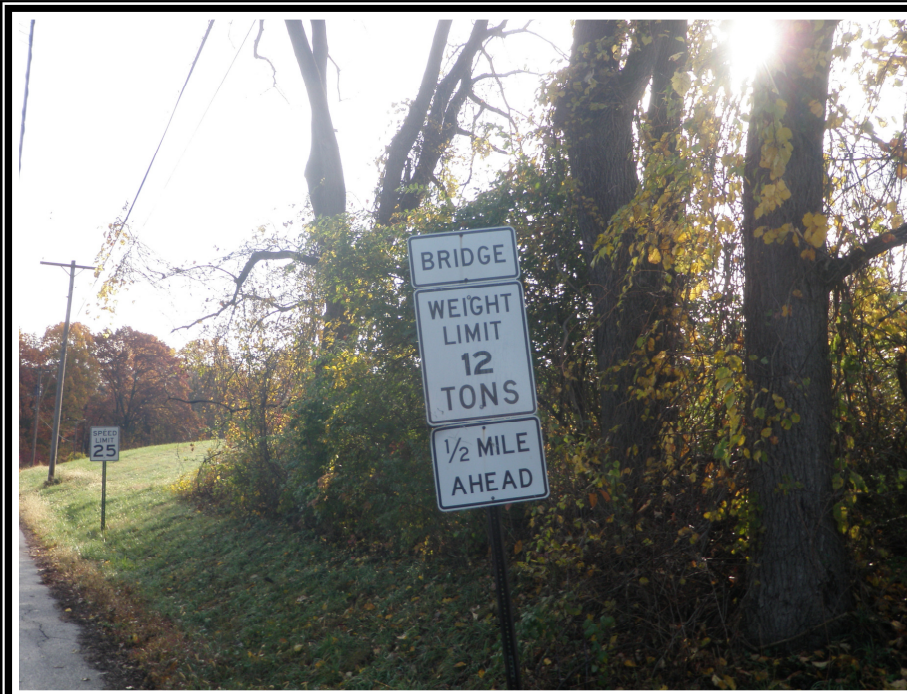
NEAR ADVANCE POSTING
West, At Zynn Road Intersection

The advance weight limit posting is slightly leaning but otherwise in good condition.

Replace the “Weight Limit 12 Tons” signs with the “Weight Limit 6 Tons” signs at both advances and approaches.

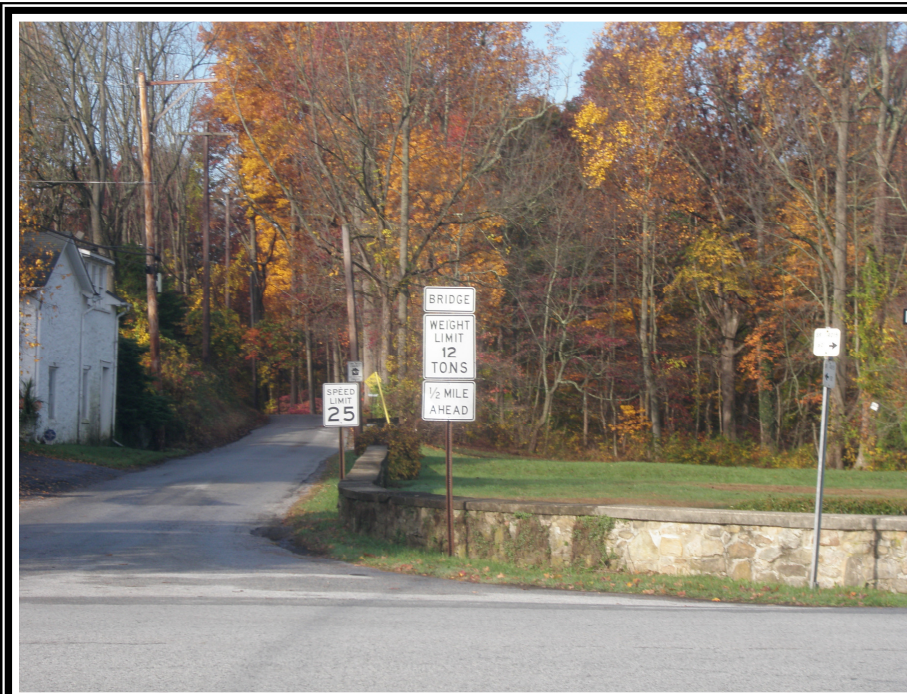
FAR ADVANCE POSTING
East, At Bondsville Road Intersection

All required signs are in place with no problems noted.

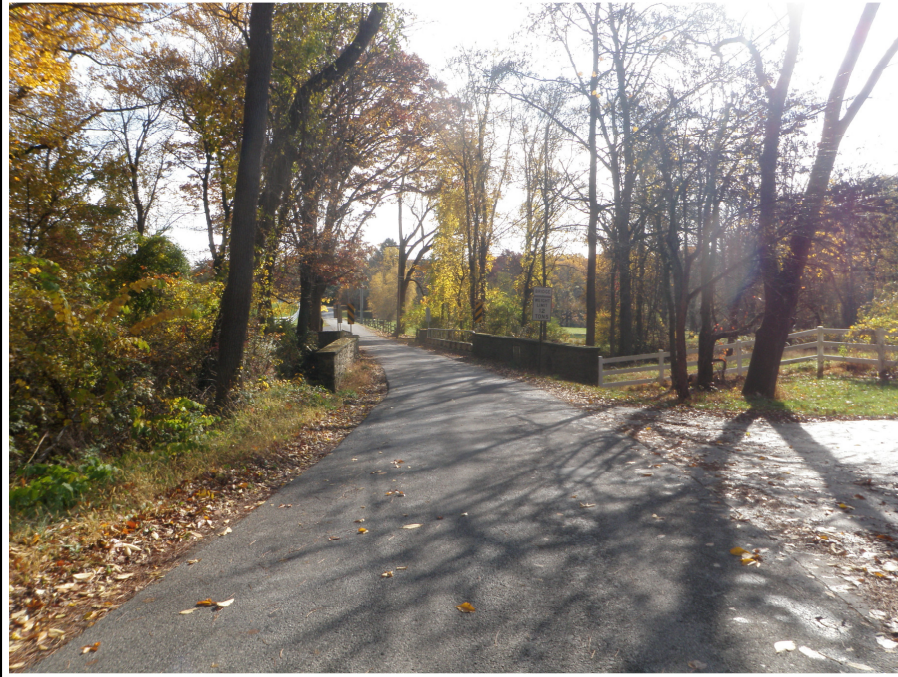
NEAR APPROACH

All required signs are in place with no problems noted.

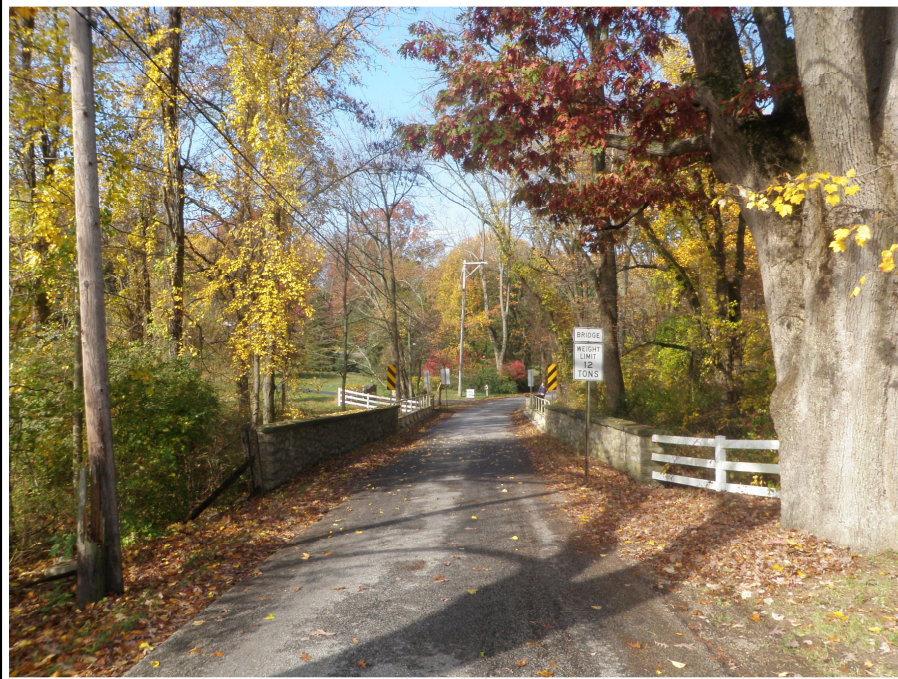
FAR APPROACH

All required signs are in place with no problems noted.

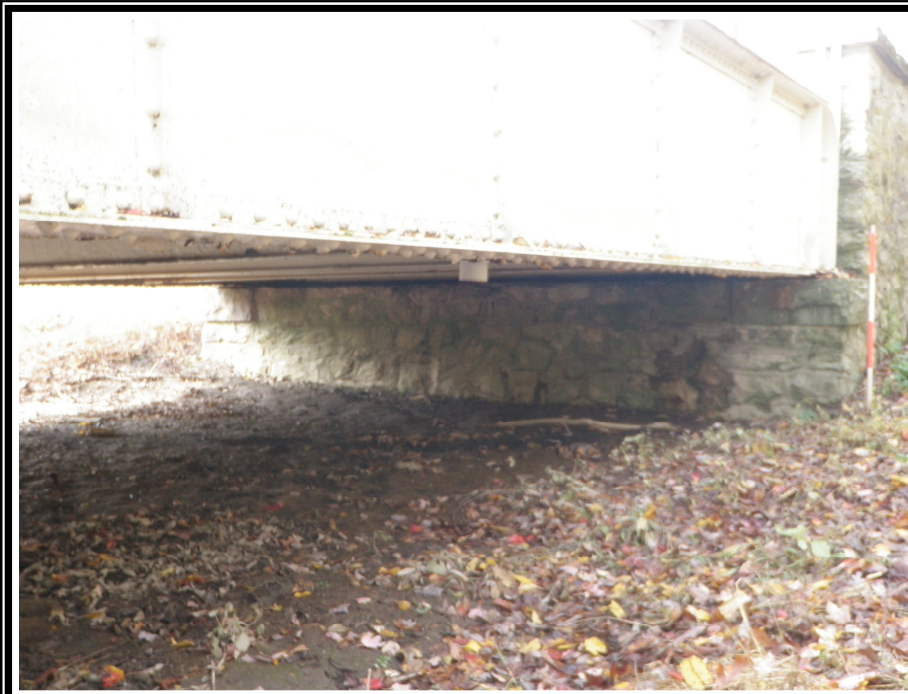
NEAR ABUTMENT
West

The stone masonry stem wall is in overall good condition with no problems noted.

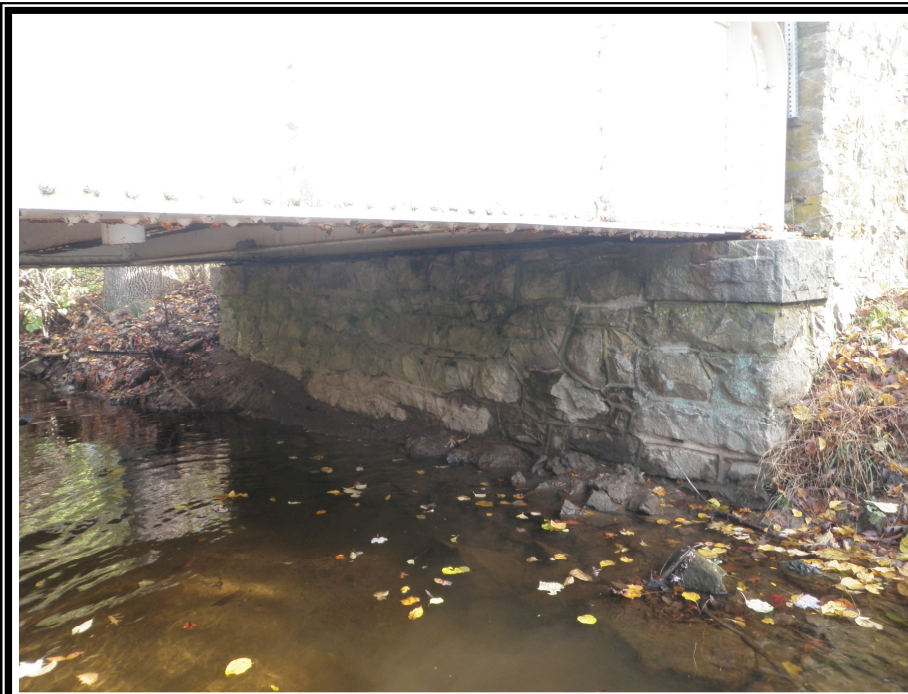
FAR ABUTMENT
East

The stone masonry stem wall is in overall good condition and is partially protected by rip-rap with minor scour of the streambed in front of the rip-rap.

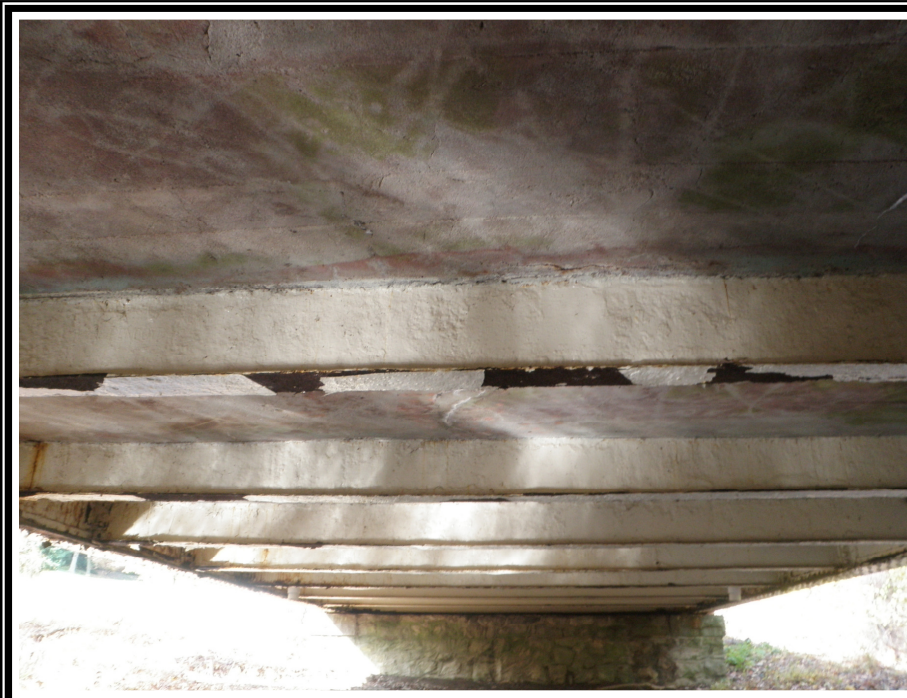
**GENERAL VIEW OF THE
UNDERSIDE OF DECK AND
SUPER STRUCTURE**

The deck is in overall poor condition due to map cracking with leaching and stalactites at the cracks. There are numerous patched spalls adjacent to the girders and spalling along the right girder.

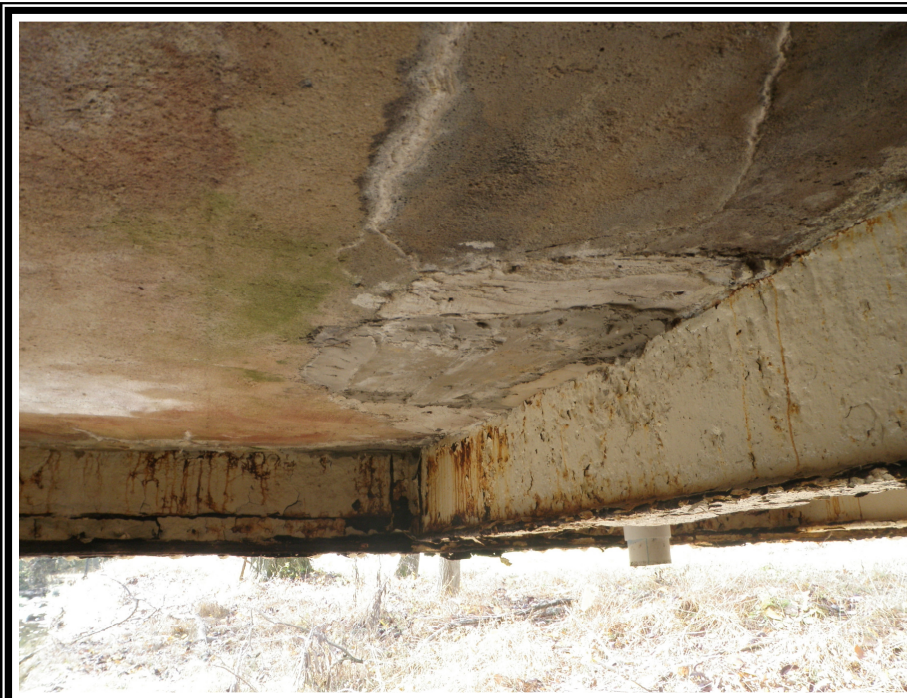
**REINFORCED CONCRETE
DECK, BAY 5**

The concrete patch adjacent to the far face of Floorbeam 5 is intact with no problems noted.

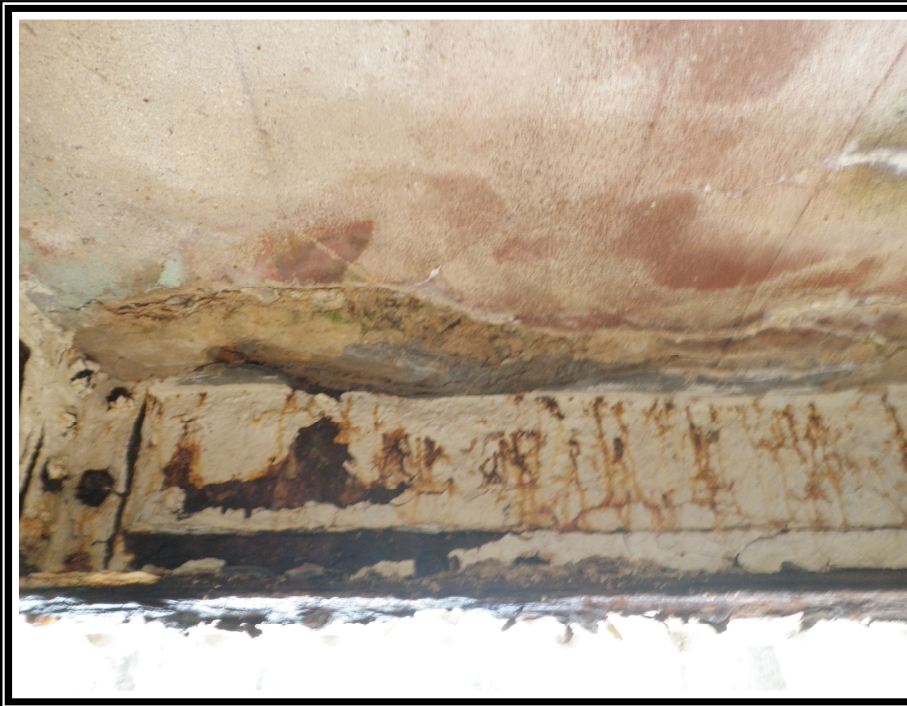
DECK UNDERSIDE, BAY 6
Right Girder, Looking Downstream

Bays 5 and 6 exhibit approximately 2' long x 8" wide x 1" deep spalling adjacent to the right girder.

There is a 2' long x 8" wide x 1" deep spall adjacent to the right girder and the surrounding concrete is wet and delaminated.

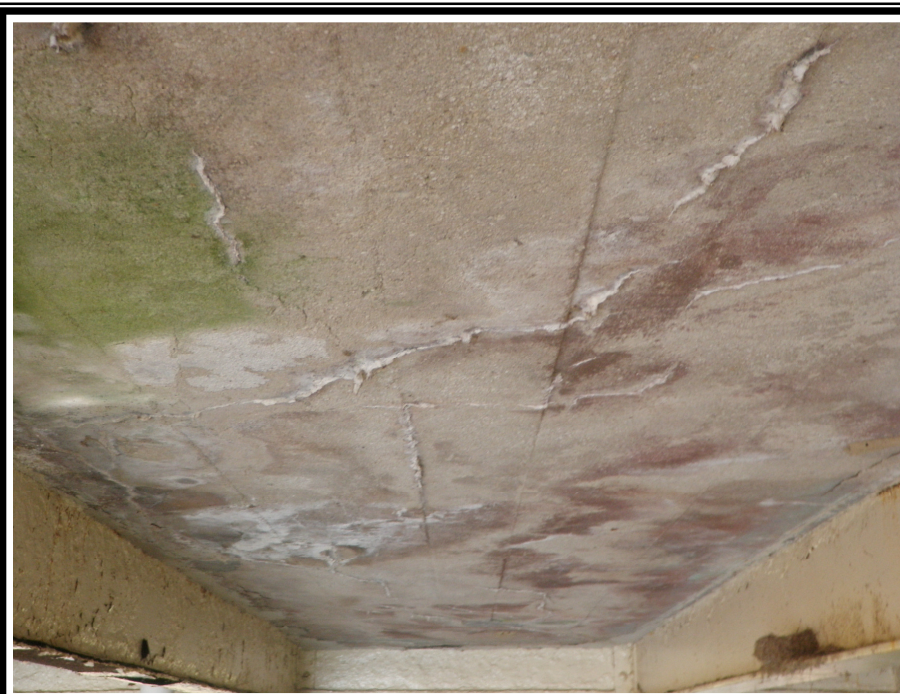
DECK UNDERSIDE, BAY 9
Looking Upstream

Typical hairline to 1/16" wide random cracking with efflorescence throughout.

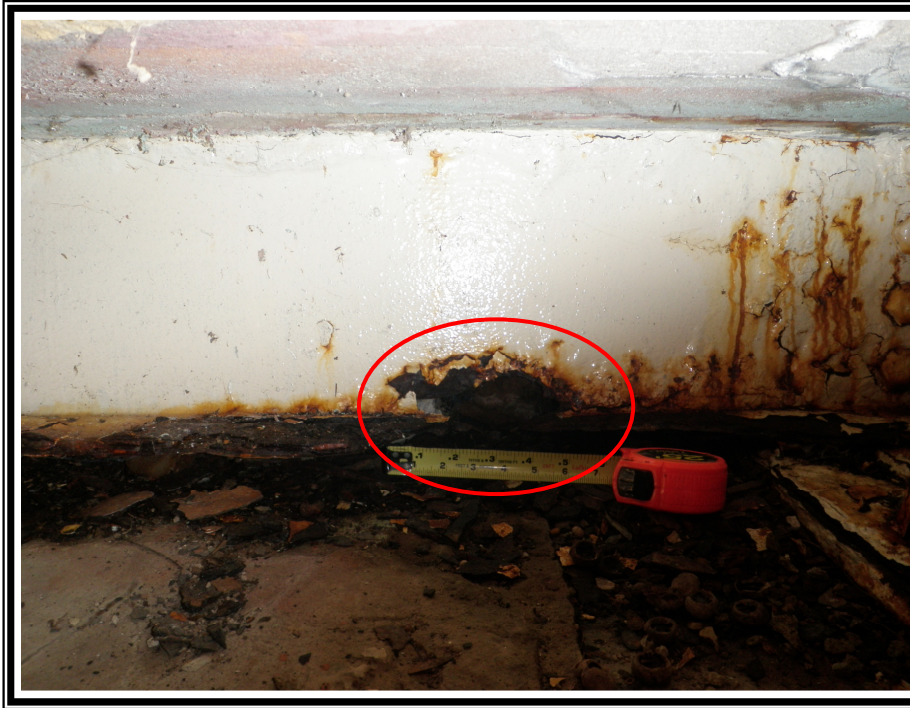
NEAR END FLOORBEAM

There is a 5" long x 1" high area exhibiting 100% section loss to the web adjacent to the bottom flange.

Repair or replace the steel floorbeams due to continued delamination with up to 100% section loss to isolated locations of the webs and bottom flanges.

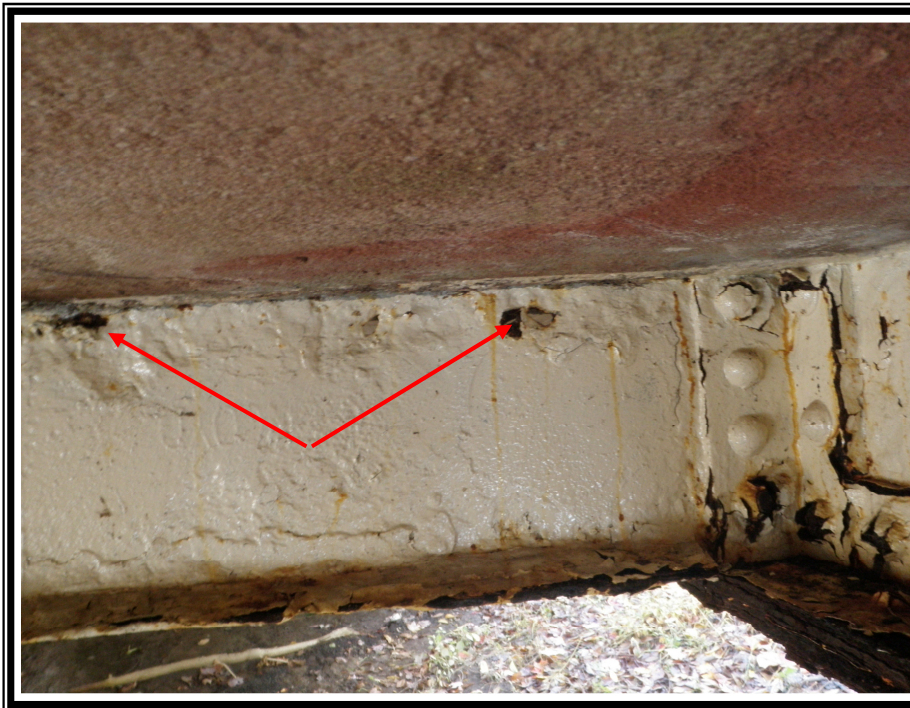
FLOORBEAM 4

There are two 1" square areas of 100% section loss to the web of the beam adjacent to the top flange. The web between the holes exhibits prior section loss and pitting. The first hole is within 1' of the connection with the left girder.

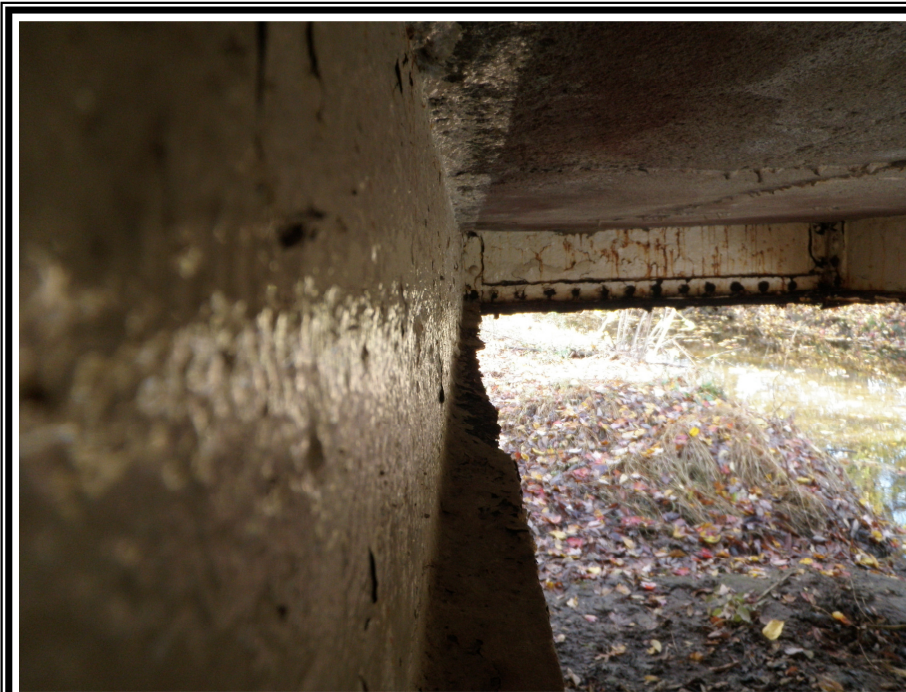
FLOORBEAM 4 BOTTOM FLANGE

The bottom flange width and thickness are reduced due to corrosion and section loss.

Comments/Assumptions*: FLOOR BEAM WEB ASSUMED $\frac{1}{4}$ " SECTION LEFT IN
WEB, BOTTOM FLANGE WIDTH HAS $\frac{1}{8}$ " SECTION LOSS AND 4"
WIDTH REMAIN. (BEAM #4).
BRIDGE SHOULD BE POSTED FOR 6 TONS.

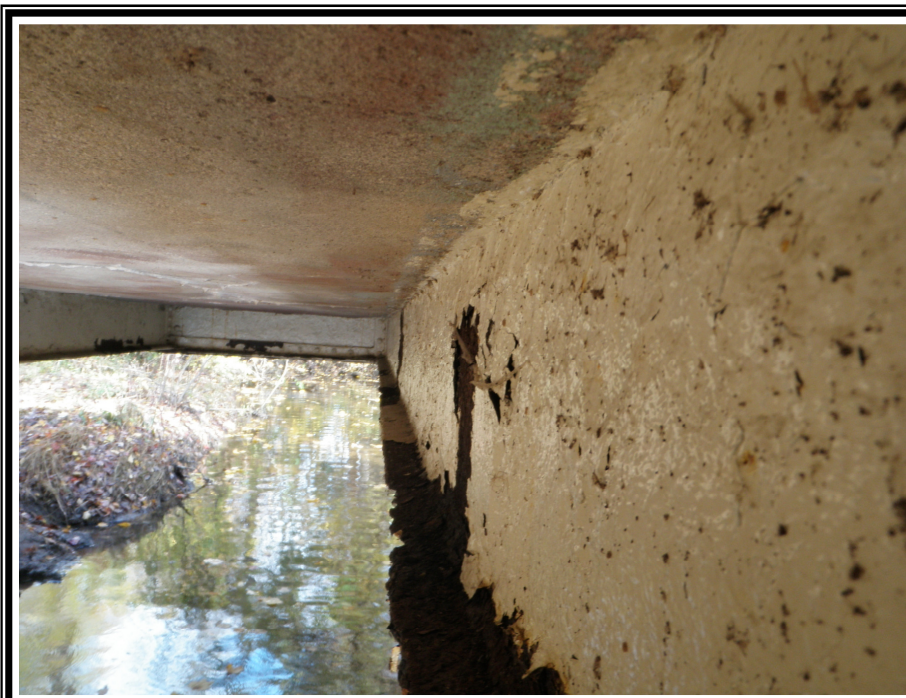
FLOORBEAM 7

There is severe corrosion along the bottom flange with typical 1/8" section loss and portions corroded 100% of the flange thickness.

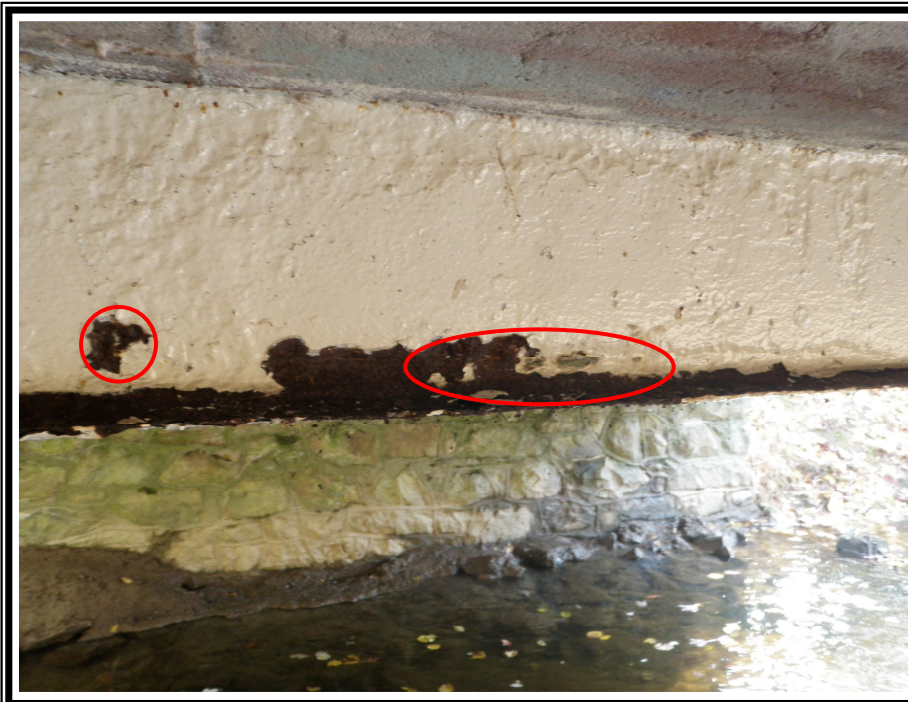
FLOORBEAM 8

There are three areas of 100% section loss through the web of the floorbeam adjacent to the bottom flange measuring 5" long x 1/2" high.

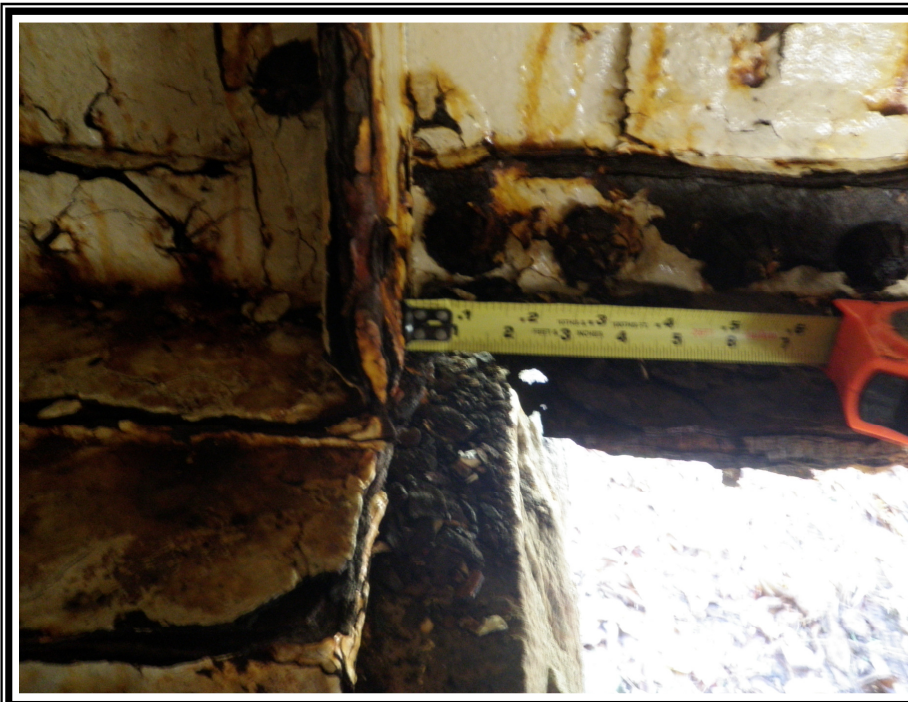
LEFT GIRDER BOTTOM FLANGE

The girder bottom flange adjacent to the near left bearing stiffener exhibits 100% section loss for the full width of the bottom leg of the interior angle for a length of 3".

Repair or replace the steel girders due to continued delamination with up to 100% section loss to the bottom flanges adjacent to the near bearing stiffeners.

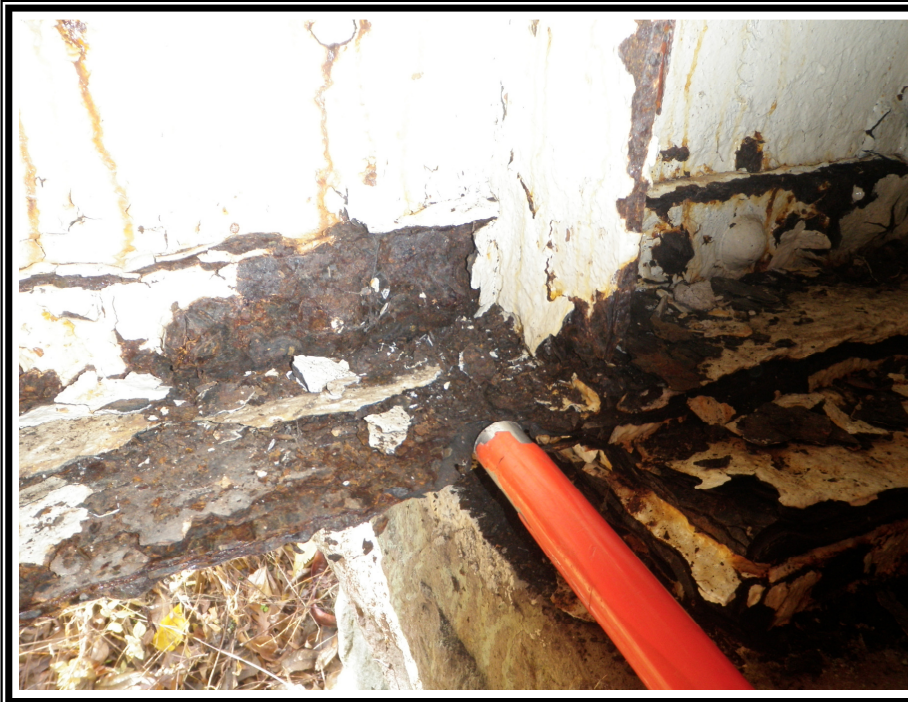
**RIGHT GIRDER BOTTOM
FLANGE**

The girder bottom flange adjacent to the near right bearing stiffener exhibits 100% section loss for half the width of the bottom leg of the interior angle.

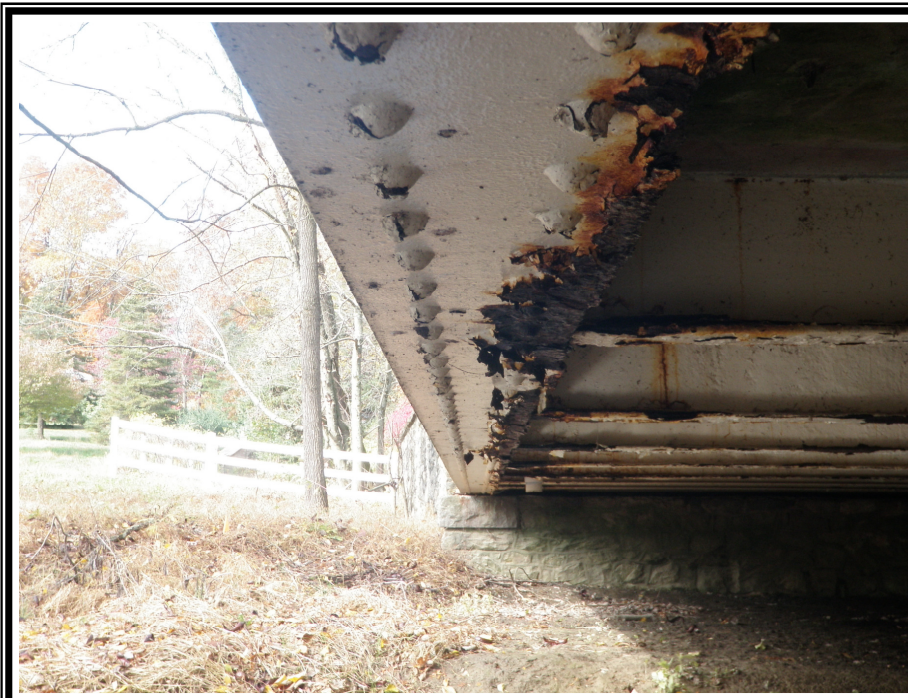
**RIGHT GIRDER BOTTOM
FLANGE**

Girders/Beams: The 3' - 9 1/4" deep riveted steel plate through-girders exhibit typical heavy corrosion at joints and along the bottom flanges with approximately 15% section loss. The bottom flange effective width is 11 - 1/4" compared to the original width of 12". There is moderate corrosion of the webs with approximately 15% section loss and the rivet heads exhibit up to 30% section loss.

Heavy corrosion to the bottom flange with up to 15% section loss is typical. Additionally, there is approximately 30% section loss to the rivet heads and the bottom flange effective width is 11 – 1/4” wide compared to the original 12” wide. The interior face of the girder below the deck is saturated with severe delamination.

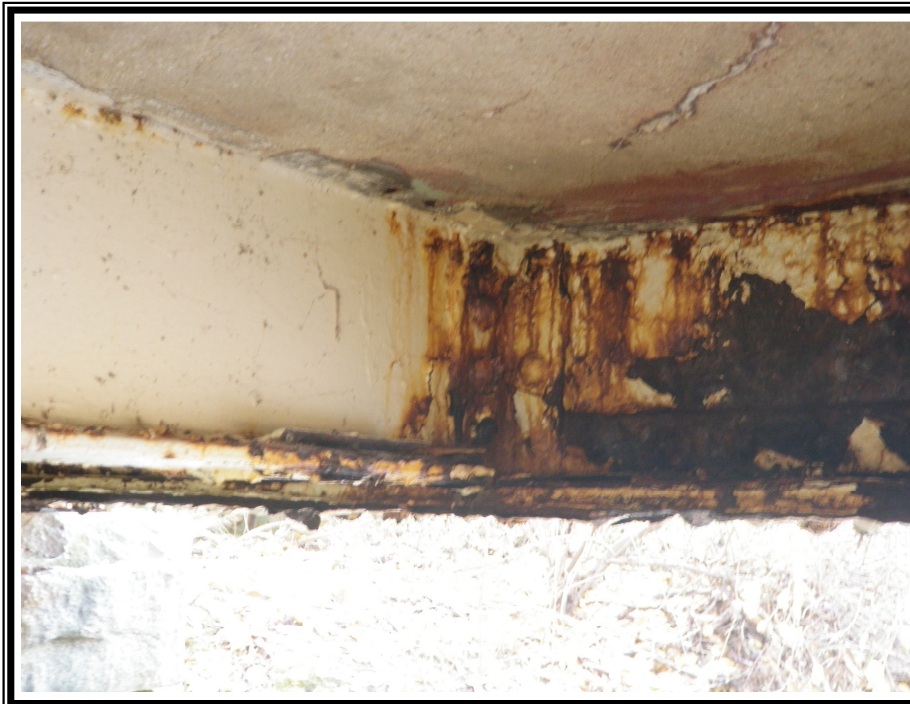
FLOORBEAM 10 & RIGHT GIRDER CONNECTION
Fracture Critical Detail

IF04 Member Detail: Out of plane bending.
IF06 Notes: No cracks noted. Severe corrosion of flanges, rivets, girder webs.

There is severe corrosion of the flange, rivets, and girder webs with no cracking noted.

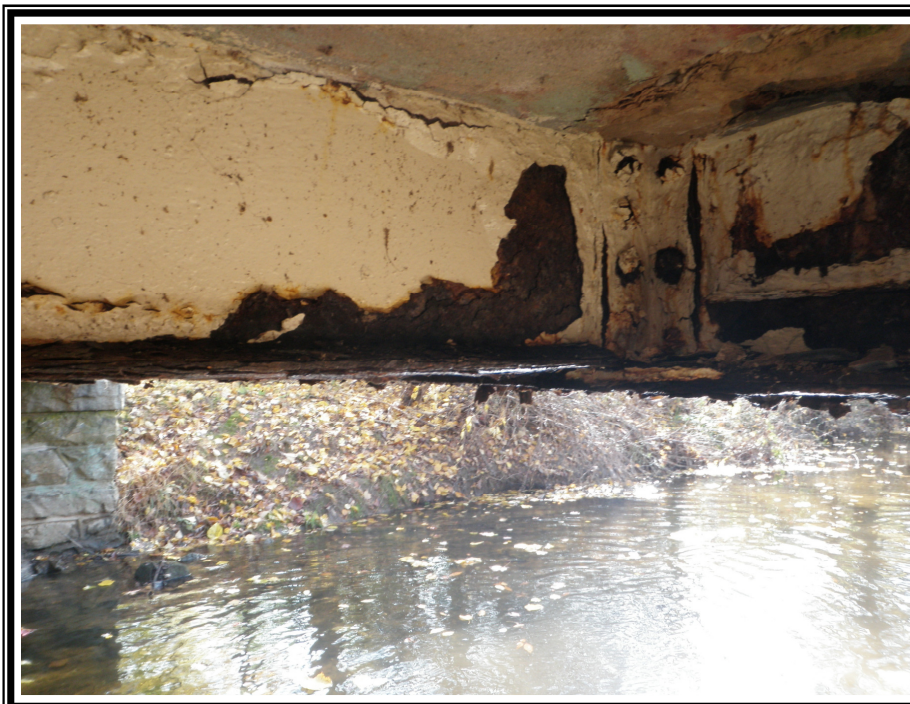
FLOORBEAM 7 & RIGHT GIRDER CONNECTION
Looking Downstream

The paint system on this structure has failed throughout the floorbeams and the interior faces of the girders below the deck. Loss of section and deep pitting has occurred affecting the strength of the members. Cleaning and painting of the entire bridge is needed.

The paint system has failed throughout the underside of the superstructure and the steel is wet and delaminated.

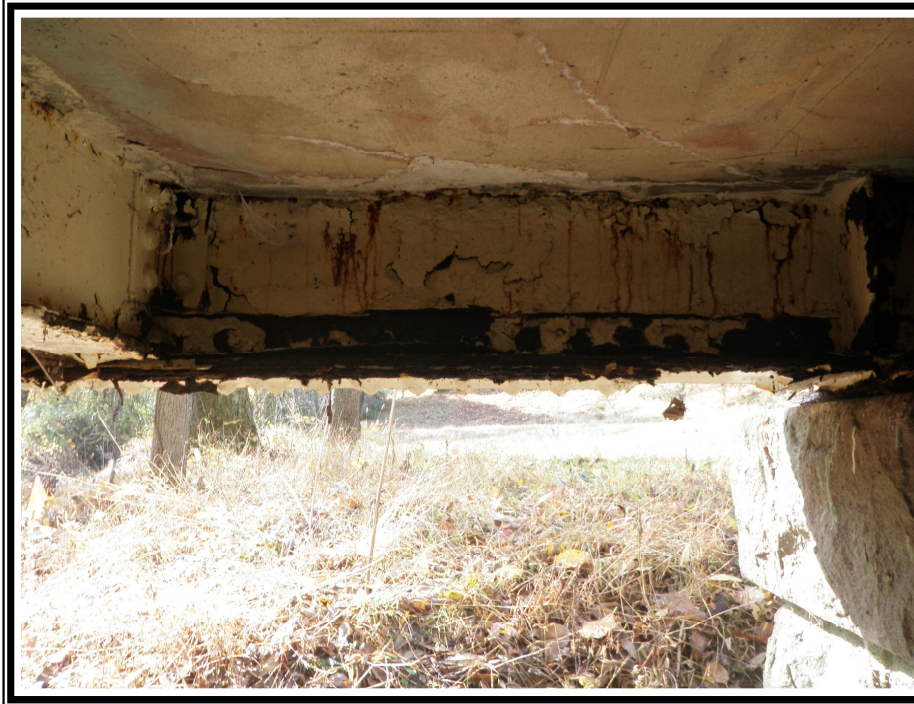
RIGHT GIRDER

There is severe corrosion of the flange, rivets, and girder web, typical.
