15 7015 0415 0244

Hadfield Road
over
Beaver Creek

INSPECTED: October 28, 2010 - Routine

PREPARED BY:

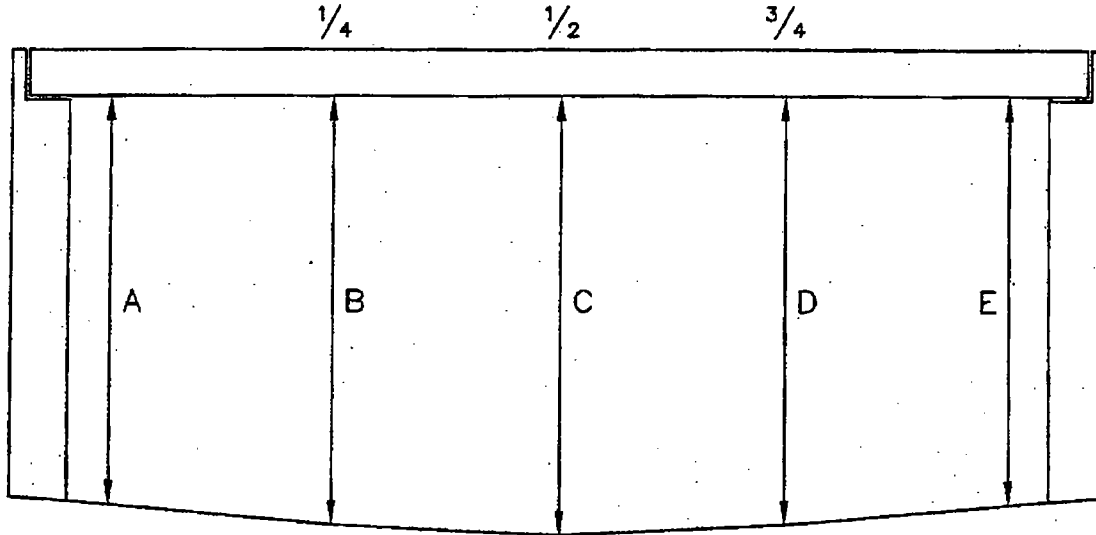
CROSS SECTION SCALE: N.T.S.

Left Elevation		Upstream									
Year		2010									
FAR	A	3.1'(0.0')									
	B	5.1'(0.5')									
	C	5.6'(1.1')									
	D	3.7'(0.0')									
NEAR	E	3.2'(0.0')									
Right Elevation		Downstream									
Year		2010									
NEAR	A	2.7'(0.0')									
	B	3.2'(0.0')									
	C	5.4'(0.9')									
	D	6.0'(1.5')									
FAR	E	4.7'(0.2')

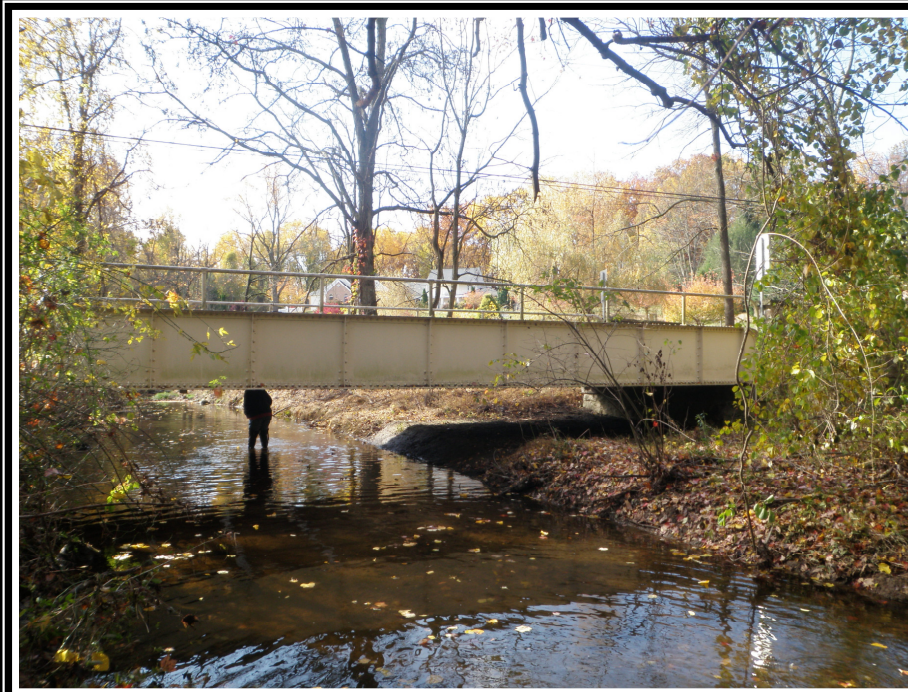
**UPSTREAM (LEFT)
ELEVATION**
North

The stone masonry stems, wingwalls and bridge seats are in good condition. The footings are below the streambed elevation. Rip-rap lines the far abutment with minor scour of the streambed in front of the rock protection. There is vegetation at the near right and far right wings.

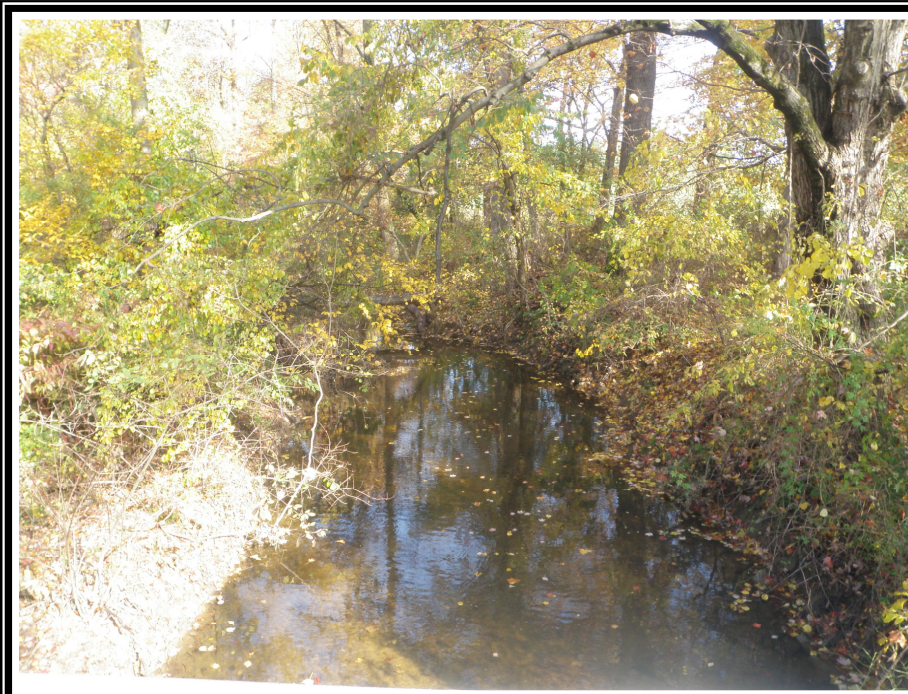
UPSTREAM CHANNEL
Looking North (Left)

The channel alignment is straight through the bridge, the stream flows through the east (far) half of the span. There is minor embankment erosion present along the upstream east (far) bank. There is minor scour present at the far abutment. The overall condition of the channel has not changed substantially since the 2008 NBIS inspection.

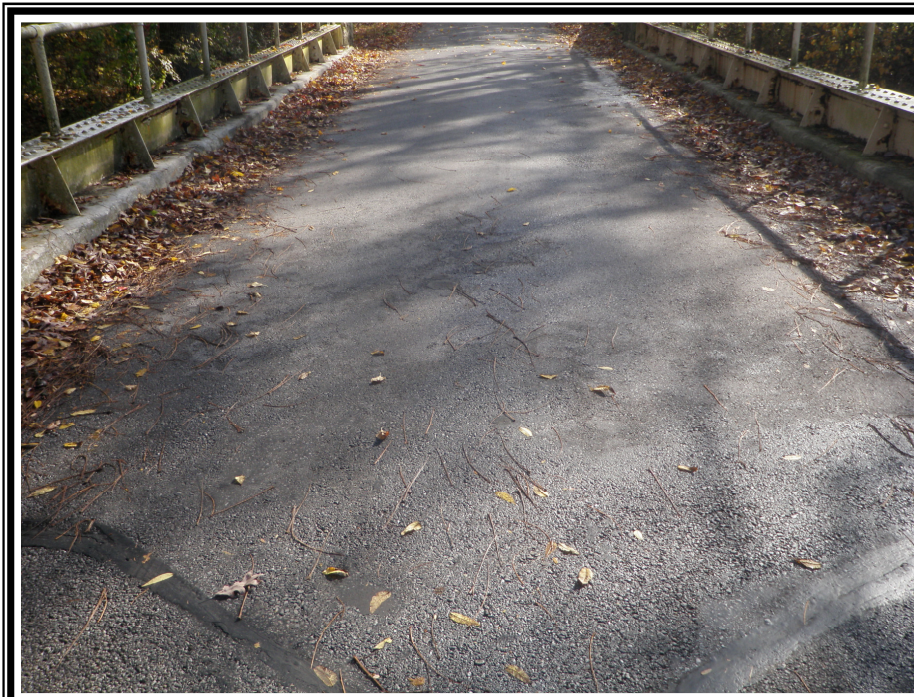
Looking Ahead

The bituminous pavement is in overall satisfactory condition with leaves and debris holding moisture along the curbs.

GENERAL VIEW OF THE WEARING SURFACE OVERLAY

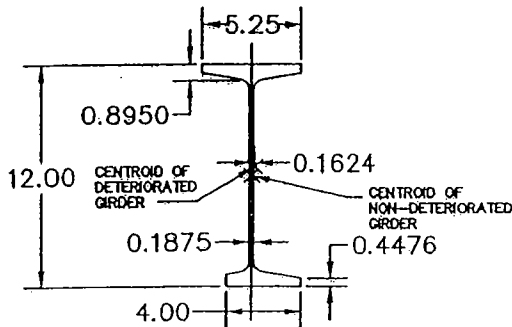
SECTION LOSS AT FLOORBEAM #4
 (VALUES FOR USE IN 244RATE7 COMPUTER RUN)

$I_x = 224.378 \text{ IN}^4$
 $A = 8.5182 \text{ IN}^2$

W&B THICK. CONSIDERING SECTION LOSS 0.1875 (3/16)

Repair or replace the steel floorbeams due to continued delamination with up to 100% section loss to isolated locations of the webs and bottom flanges.

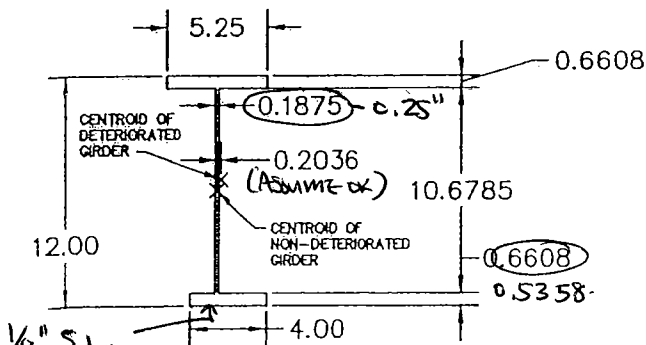
SECTION LOSS AT FLOORBEAM #4
 (VALUES FOR USE IN 244RATE6 COMPUTER RUN)

$I_x = 213.541 \text{ IN}^4$
 $A = 8.1142 \text{ IN}^2$
